Manhole Inspection Summary

Manhole # S19E__008MH

Insp Date: **10/12/07 11:50 AM**

Location Address: **2101 MULBERRY ST**

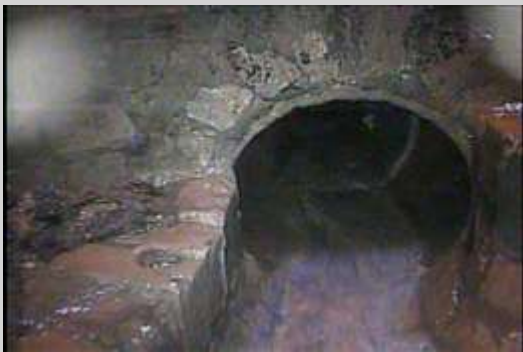
12 O'Clock Outflow

Pipe Height: **9.6** (in.) Rod and Bar (Angled)
Pipe Material: **Clay** ☐ Pipe Lined
Invert Depth: **8.40** (ft.) Flow Characteristics: **Slow**
Deposits: ☒ None ☐ Mud ☐ Sludge ☐ Debris ☐ Grease
Silt Depth: (in.) Deposits Extent:
Infiltration: **None** Pipe Seal Cond: **Sound**

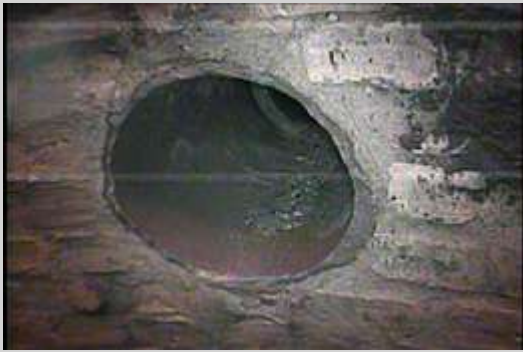
9 O'Clock Inflow

Pipe Height: **7.2** (in.) Rod and Bar (Angled)

Infiltration: **None** Pipe Seal Cond: **Sound**

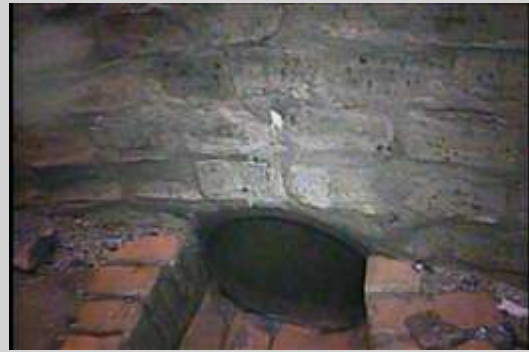
Drop In @ 9 O'Clock

Drop: Outside	Rod and Bar
Angled: Yes	Reading: 7.04 (ft.)
	Inv Depth: 8.04 (ft.)
Drop Condition: Open
